## Durham Swimming Pool Assessment Study

In the Spring of 2014, Szostak Design was commissioned by the City of Durham General Services Department to prepare a comprehensive assessment of the city's five aquatic facilities and four spraygrounds. The study was to identify and prioritize aquatic, mechanical, electrical, plumbing, structural, accessibility and energy efficiency deficiencies at each facility and include an analysis of current conditions and recommendations for improvement<sup>1</sup>. A cost model of recommended repairs and improvements was to be included in the study, as well as a projection of annual maintenance costs anticipated for each facility.

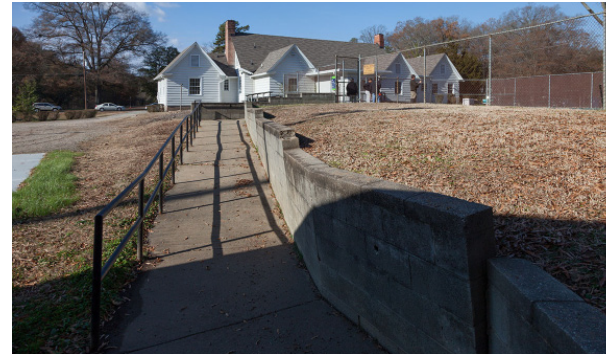
The ramped sidewalk leading from the facility's Cashier Station/Bathhouse to the pool enclosure exceeds ADA requirements for maximum slope and has a handrail on only one side. The landing at the ramp's entry point frequently floods and retains ponded water. The existing retaining wall to the east of the ramp shows evidence of significant movement, likely caused by pressure exerted on the back of the wall by the soil. This wall most likely does not have an adequate footing to resist the soil's surcharge. The movement has caused the wall to crack and separate at the corners. If left unrepaired, this wall will further deteriorate to the point of collapse in the coming years.

Top:  
Non-code compliant ramp,  
deteriorating retaining wall to  
right of photo.

Recommendation: The sidewalk, ramp and retaining wall should be replaced immediately with a fully code-compliant ramp that does not collect water. The conceptual design for this ramp replacement should preclude unauthorized access into the pool enclosure area, but should also afford easy access for maintenance personnel and equipment, likely with the introduction of a lockable gate.

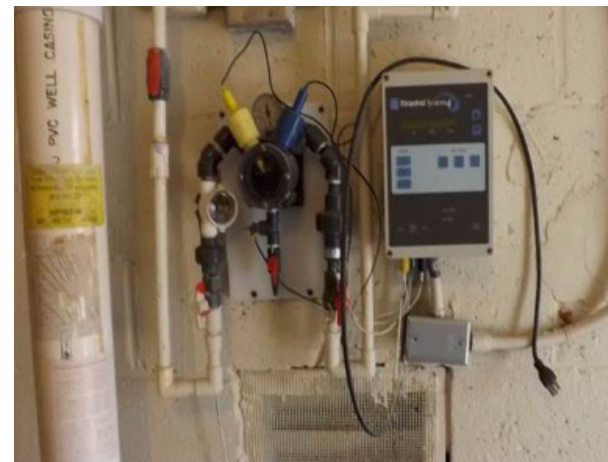
Top:  
Stanrol Chemical Controller.

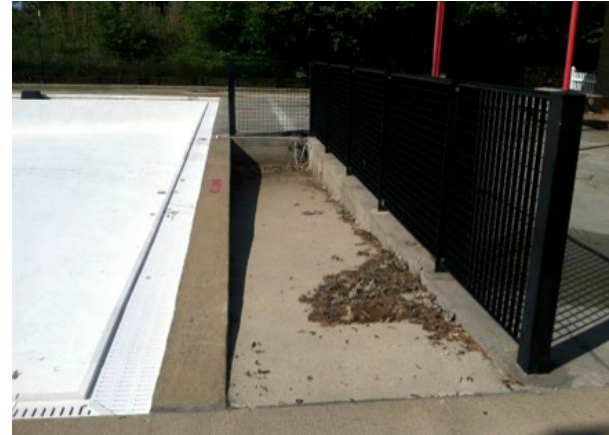
Top:  
Dry ramp.

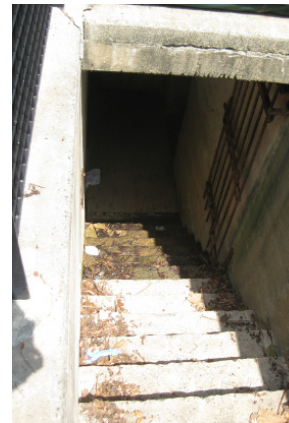
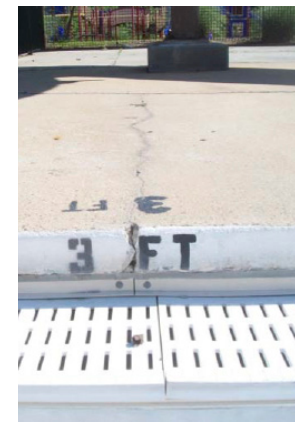
Middle Right:  
Stairs showing deterioration of treads.

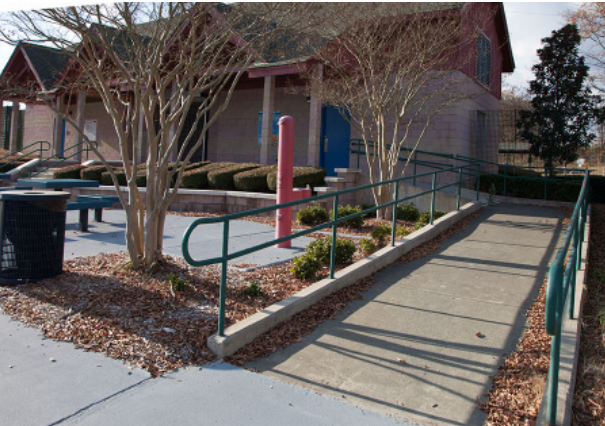
Bottom:  
Accessible ramp from pool deck to bathhouse.

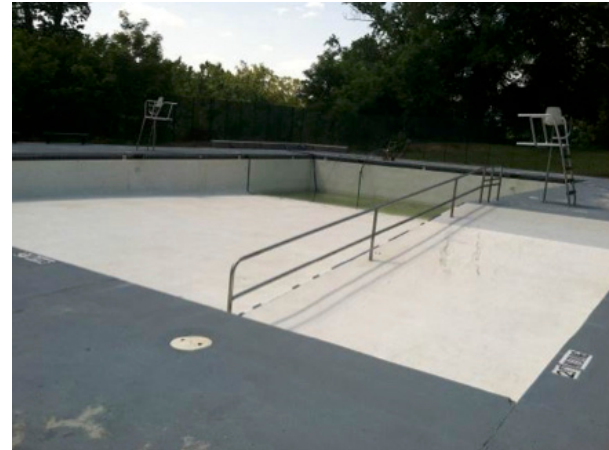
Top:  
Non-compliant pool entry ramp.

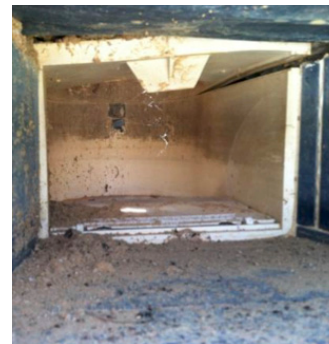
Middle Left:  
Cracked skimmer housing.

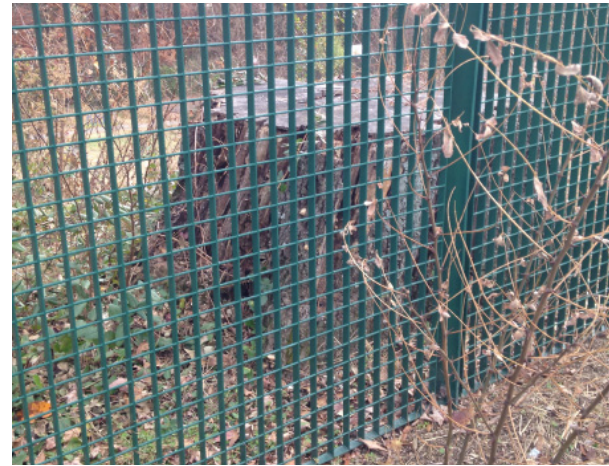
Top:  
Tree stump immediately outside  
pool enclosure fence.

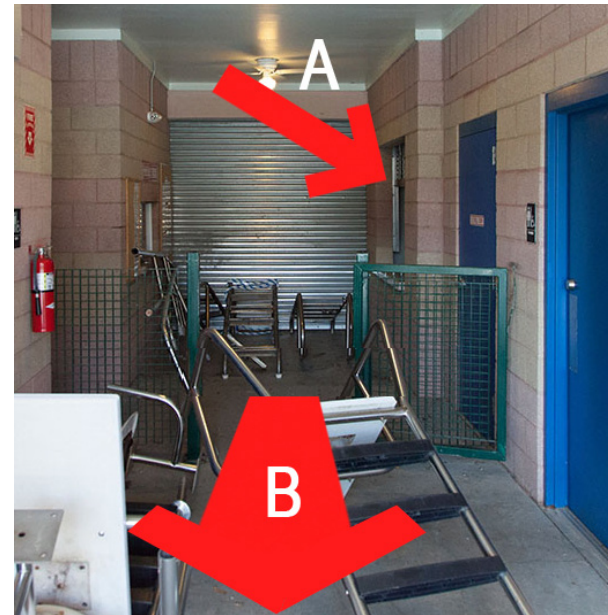
Top:  
A. Cashier's window.  
B. Path of patron circulation out of view of cashier.

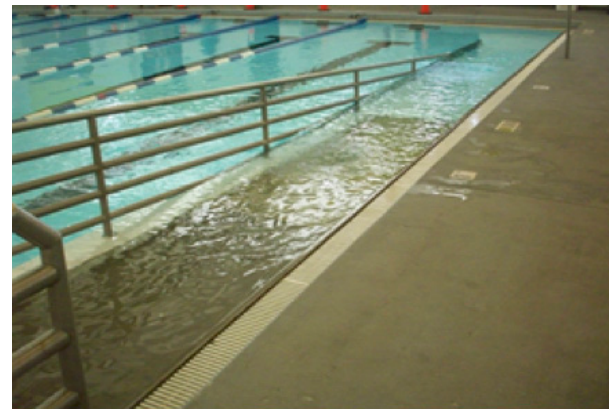
Top Left:  
Pool access ramp requiring additional handrail.

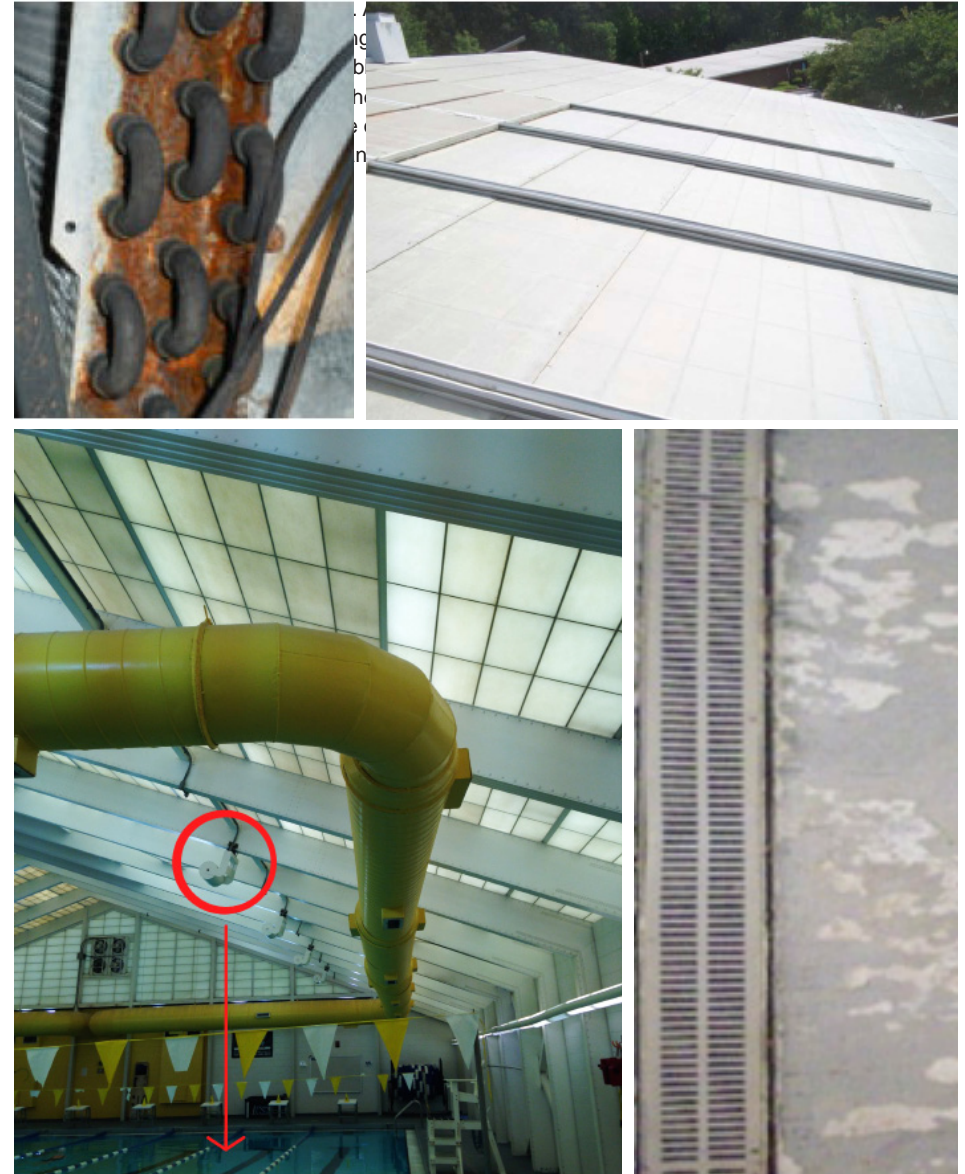
Top Left:  
Corrosion on HVAC coils.

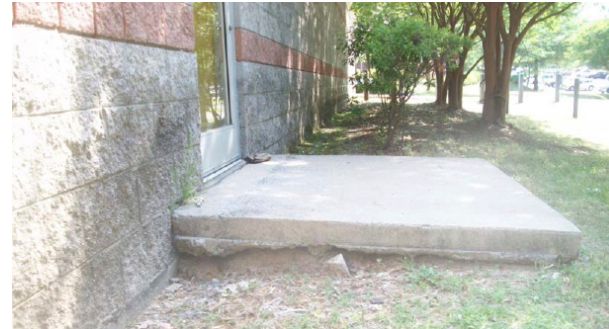
Top:  
Settlement of exterior  
concrete stoop.

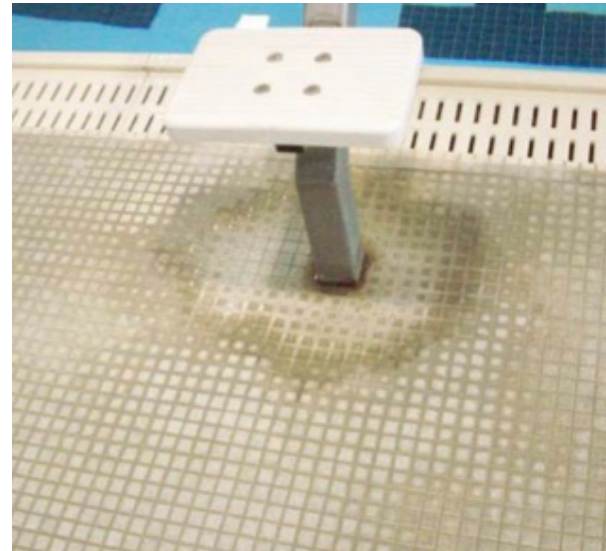
Top:  
Ponding at pool deck.

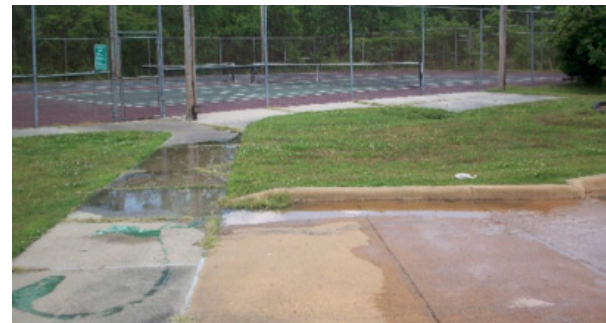
Water ponding at sidewalk.
